DEPARTMENT OF TRANSPORTATION**DIVISION OF ENGINEERING SERVICES**

Contract #: 04-0120F4Cty: SF/ALA Rte: 80 PM: 13.2/13.9File #: 1.28**WELDING INSPECTION REPORT****Resident Engineer:**Pursell, Gary**Address:** 333 Burma Road**City:** Oakland, CA 94607**Report No:** WIR-015759**Date Inspected:** 20-Jul-2010**Project Name:** SAS Superstructure**OSM Arrival Time:** 630**Prime Contractor:** American Bridge/Fluor Enterprises, a JV**OSM Departure Time:** 1500**Contractor:** American Bridge/Fluor Enterprises, a JV**Location:** Job Site**CWI Name:** See below**CWI Present:** Yes No**Inspected CWI report:** Yes No N/A**Rod Oven in Use:** Yes No N/A**Electrode to specification:** Yes No N/A**Weld Procedures Followed:** Yes No N/A**Qualified Welders:** Yes No N/A**Verified Joint Fit-up:** Yes No N/A**Approved Drawings:** Yes No N/A**Approved WPS:** Yes No N/A**Delayed / Cancelled:** Yes No N/A**Bridge No:** 34-0006**Component:** SAS OBG**Summary of Items Observed:**

WELDING INSPECTION REPORT

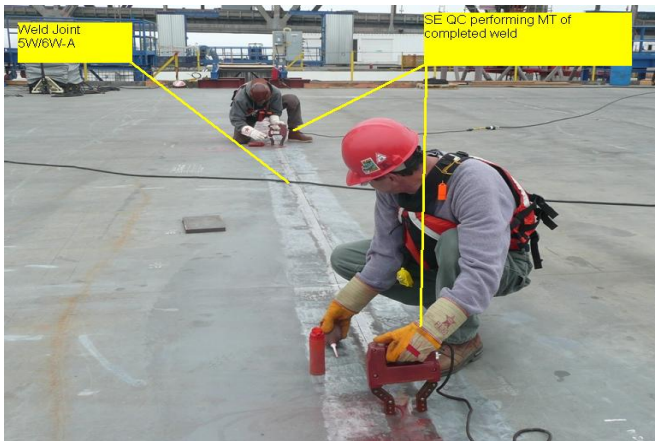
5W/6W-A1-5

Upon the arrival of the QA Inspector at the above identified location, it was observed and noted the weld reinforcement had been ground flush with the base material of the top deck plates. The QA Inspector randomly observed and noted the SE QC Inspectors Tom Pasqualone and Steve McConnell performing magnetic particle testing of above identified weld joint. The QA Inspector randomly observed the above identified QC Inspectors perform MT of 100% of the total weld length of the above identified weld joint. The QA Inspector noted no relevant indications were located at the time of the testing. The QA Inspector performed 10% MT verification of the total weld length in weld segment identified as A2. The QA Inspector noted no relevant indications were located at the time of the testing (see TL-6028 for additional information).

The SE QC Inspector Steve McConnell informed the QA Inspector the MT of the 5W/6W-A weld CJP weld joint was acceptable. Mr. McConnell informed the QA Inspector he would likely begin the ultrasonic testing tomorrow 7-21-10.
